Rollout Instructions: How to Update the Software on Merco Hot Holding Cabinets

Introduction

This document provides instructions for updating the Merco Hot Holding Cabinet software to enable units to connect to Wi-Fi and update the menu list on the device to include cheese sauce and burritos. This is to be used with the Digital Checklist provided by the Chick-fil-A DFS Team. The digital checklist is a Smartsheet Form available here: [Merco Update Form for DFS](#).

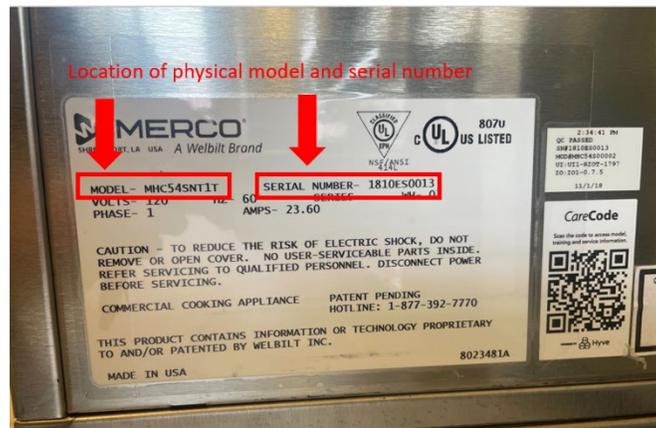
1. Take a picture of the Data Sticker and record the Model Number and Serial Number
 - a. If it is missing the data sticker, please record its status: missing/illegible

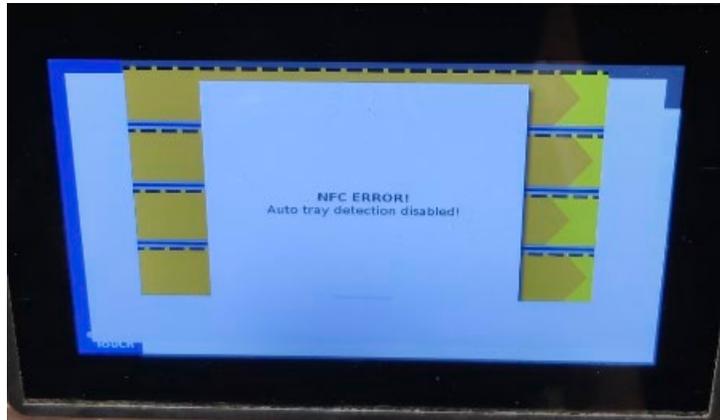
d.1. NFC Errors can be ignored

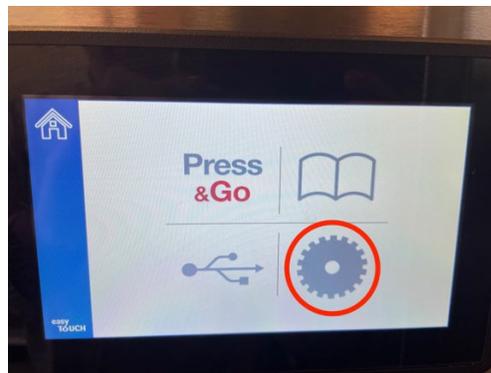
3. Press the Home button and then press the gear icon seen below:

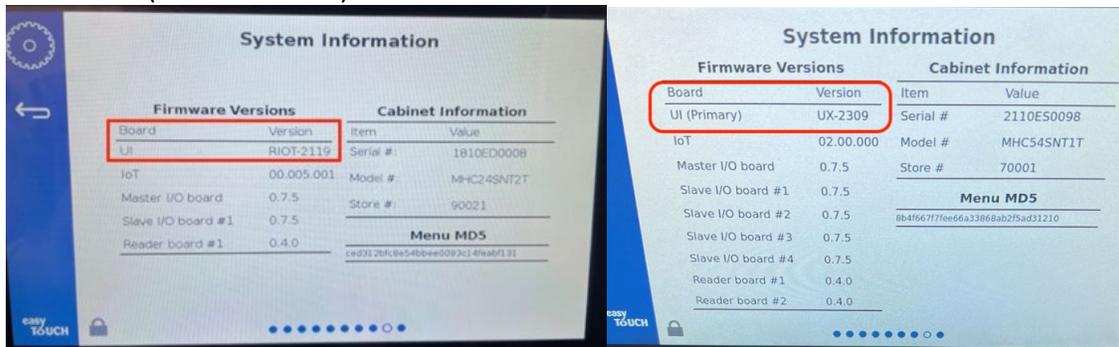
- Determine if the UI (User-interface) is a **RIOT-****** or if it is a **UX-****** interface

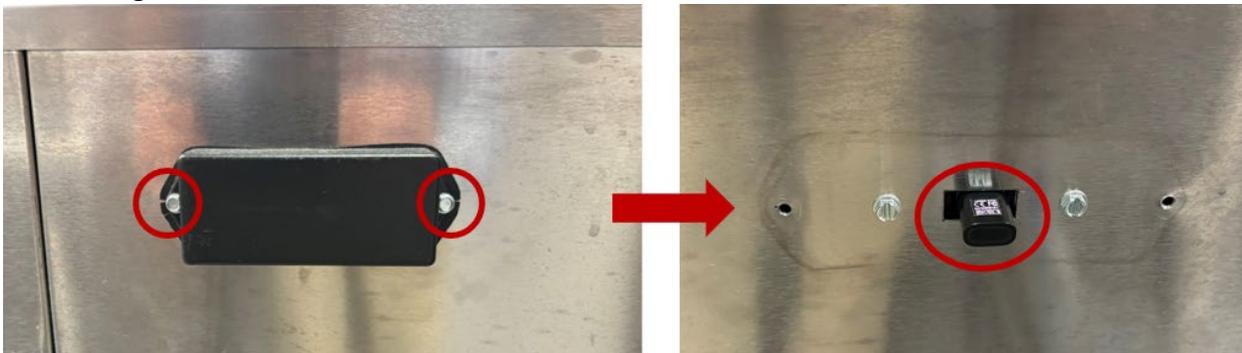
13. Remove the plastic cover located on the back of the cabinet by using a 1/4" nut driver to remove the two screws holding the cover onto the unit.

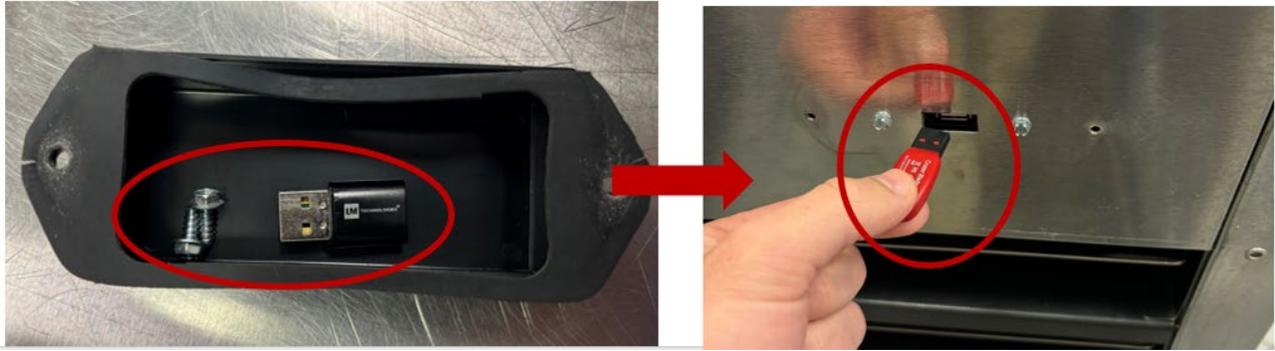
14. Remove the USB device that is currently in the USB port. This device is called a Wi-Fi dongle. You will reinsert this later after the update is completed.
 - a. The Wi-Fi dongle may be missing, and a spare can be installed after the update is completed
 - b. Place the two screws and Wi-fi dongle in the cover to not lose the parts during the update
15. Insert the USB flash drive (with the required software file for the correct Model Number and UI version).

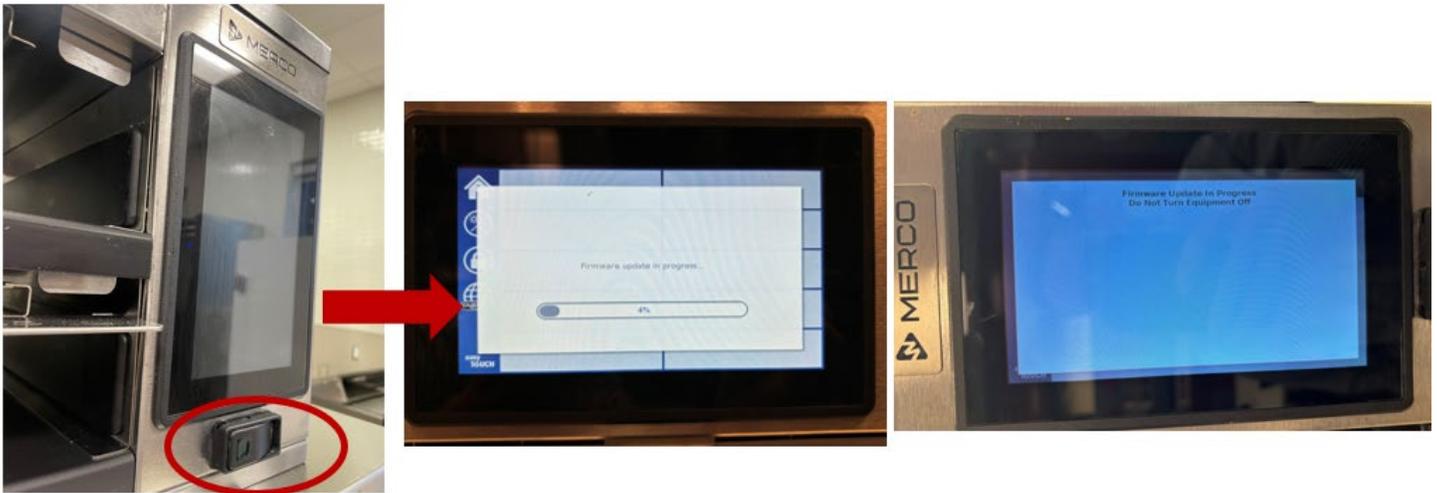
16. Power ON the unit by pressing the power switch

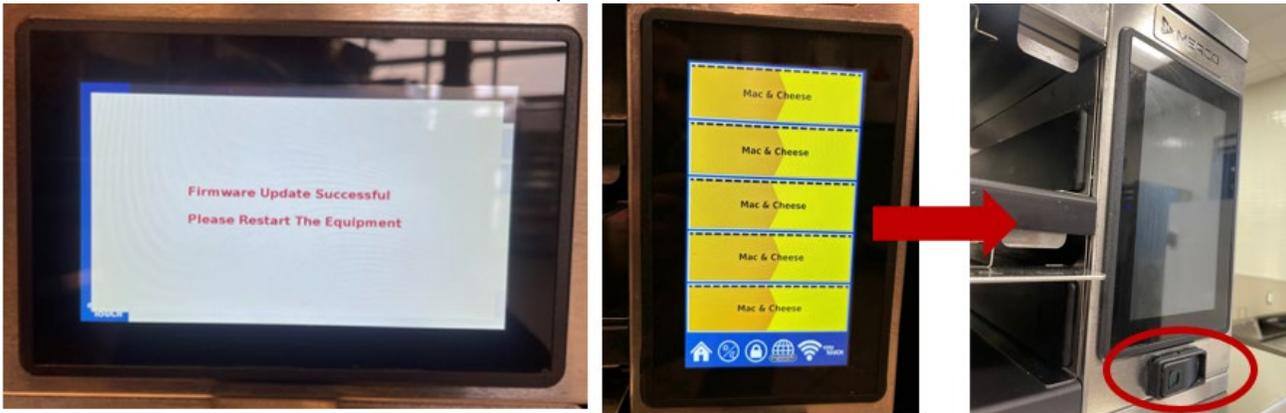
18. The update is quick and will not take more than a few minutes and will display “**Firmware Update Successful**” at the end of a successful update.

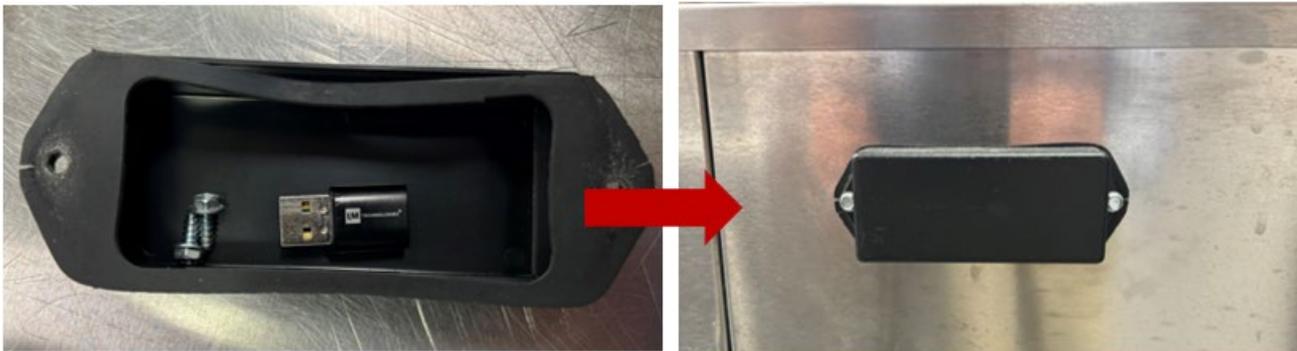
- a. Power off the unit.
- b. Remove the USB flash drive
- c. Insert the USB device that was previously in the USB port (i.e., the Wi-Fi dongle)
- d. Re-insert the plastic cover (and gasket if it was removed or fell off) and ensure to not overtighten the screws
- e. Power ON the unit

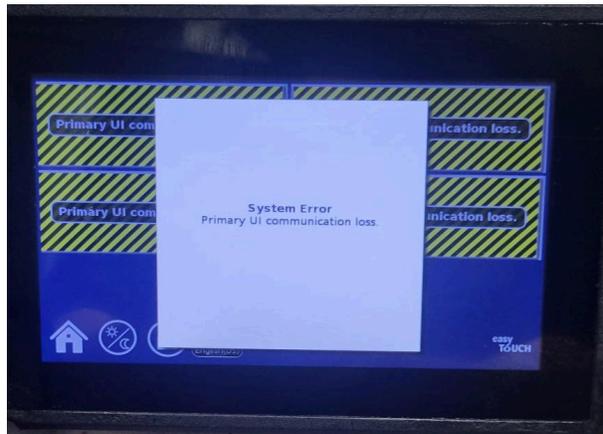
- a. At the primary display, select the **HOME** icon -> then **Gear** icon
- b. Swipe to the **Systems Information Page**
- c. Confirm the **RIoT SDK** displays version **2.1.0-GO**
If the RIOT SDK displays **2.1.0-GO**, then the update was successful
- d. Record the updated **UI Version**
Starts with either RIOT-XXXX or UX-XXXX
- e. If RIoT SDK version is blank, missing, or displays a question mark, please follow the troubleshooting guide below to address the issue
- f. Note: Immediately following the update, the secondary User Interface (which may be on the back of the unit) will say that it has lost connection to the primary UI. This is expected behavior which should correct when the unit is restarted. See following image:

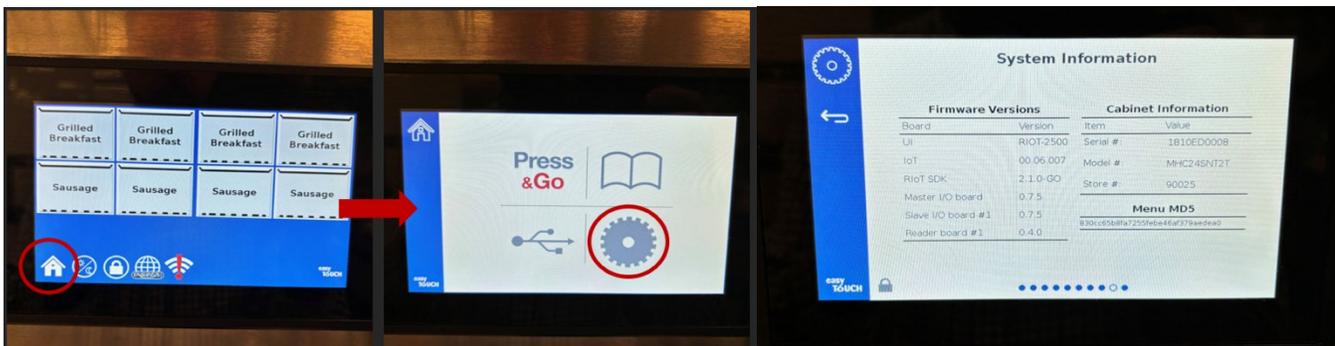
- g. Note: After the update is successful, the secondary UI will incorrectly say it is on the vdown network. This is expected behavior which will be corrected in a future update.

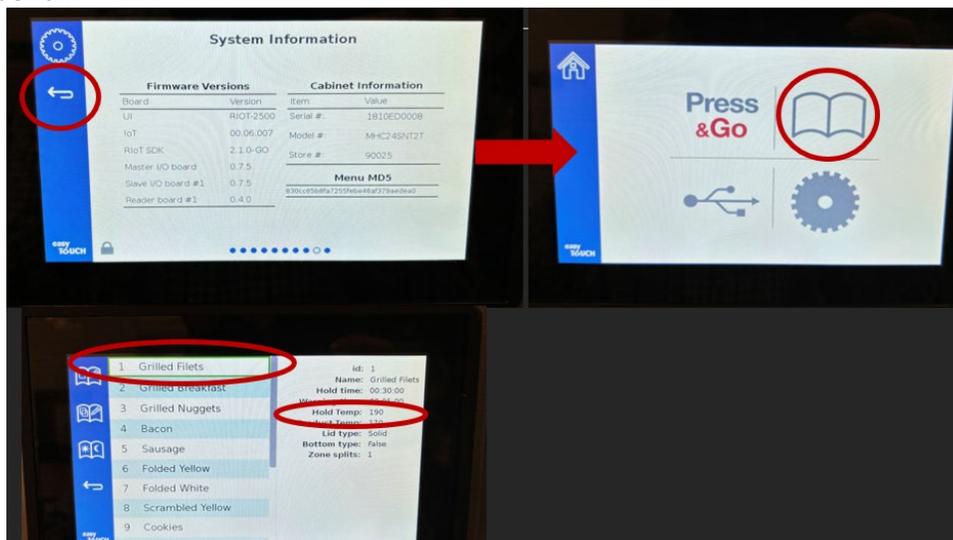
- From the **Home Page**, Press the **Menu Icon** and scroll to **Grilled Filets**, select **Grilled Filets**
- For **MHC22** or **MHC24** model units, the **Hold Temp** should be **200 F**
- For **MHC52** or **MHC54** units, the **Hold Temp** should be **190 F**
- If the unit has the incorrect temperature, please follow troubleshooting instructions in the appendix

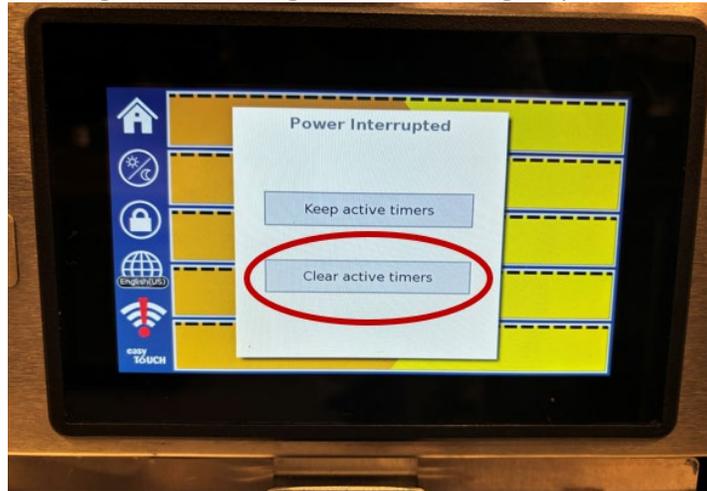
- A. If there are active holdings on the unit, the update will not start
 - a. Turn the unit OFF and back ON
 - b. Display will provide option to “Clear Active Timers”, Select “Clear Active Timers”
 - c. Repeat steps 13-24
 - i. If the issue persists, with the unit ON, remove the USB and insert it back into USB port, wait 5 minutes before following the remaining troubleshooting steps below.

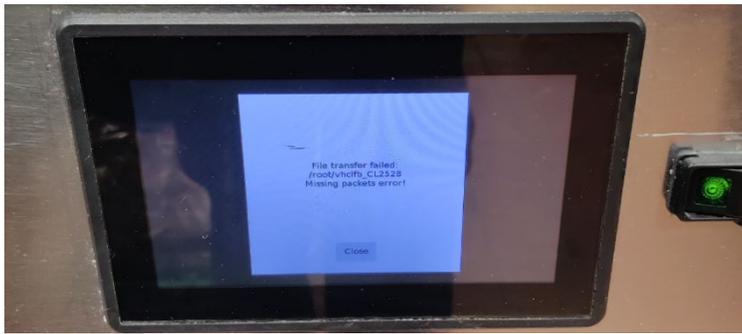
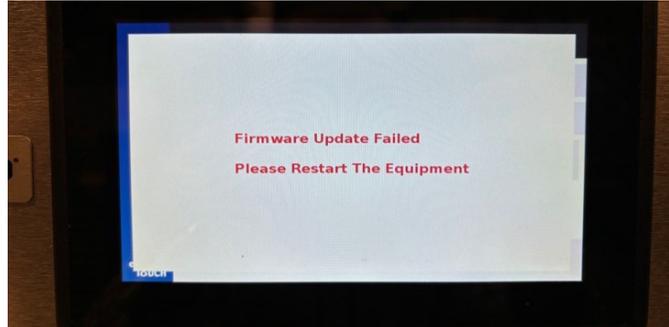
If the unit begins to update, but then displays **“Firmware update Failed, please restart the equipment”** on one display and on the other displays **“File Transfer Failed: Missing Packets Error!”**

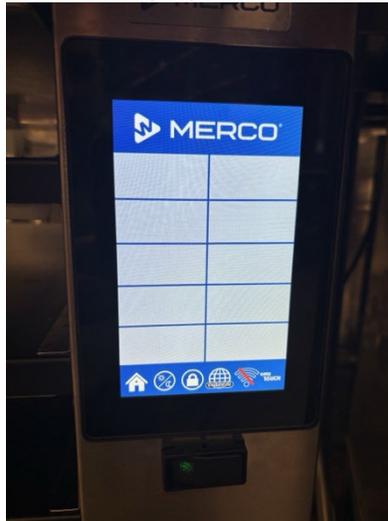
After successfully updating the Merco Cabinet, it displays blank boxes for all the product holdings

- A. If this occurs, power the unit OFF and back ON to resolve the issue
- B. The issue should not impact the update process, nor should it impact operations once it is power cycled.

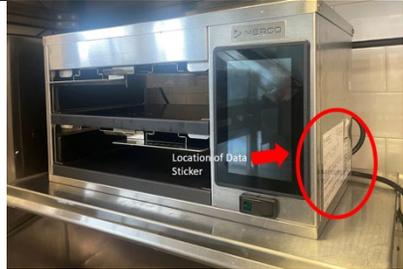
Model Number	# of Rows & Columns	Description	Image	Location of Data Sticker
MHC22SNT1T	2x2	Front Display

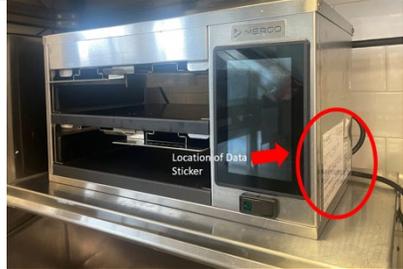
MHC22SNL1T	2x2	Front Display Landscape

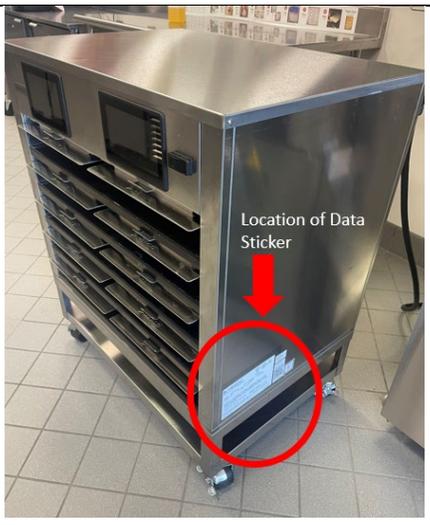
Data Sticker Located on Right Hand side of unit
MHC54SNT1T	5x4	Front Displays

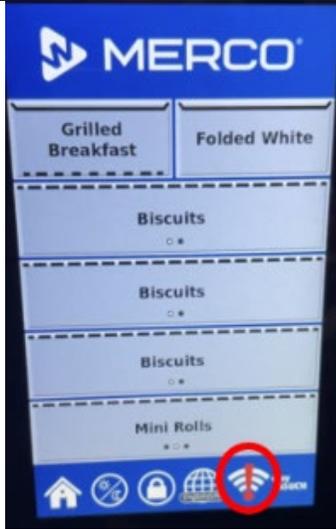
Solid White Wi-Fi Emblem with exclamation point

Provisional Network

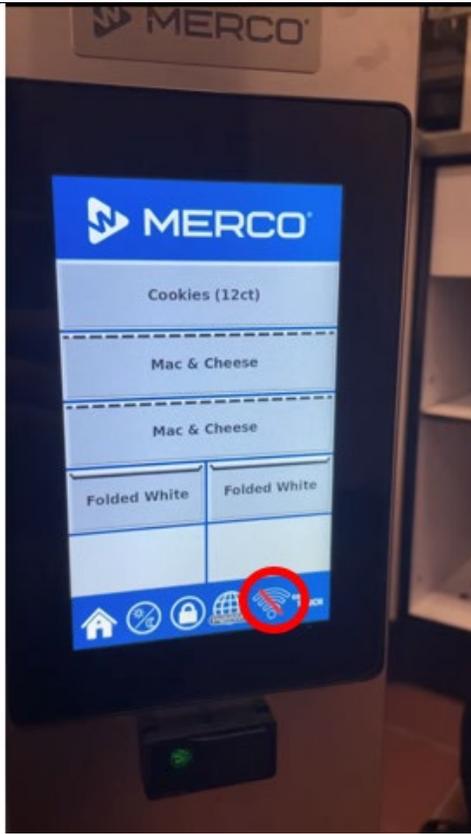
Outlined Wi-Fi emblem with a blank center, set against a blue background with a diagonal slash

Disconnected
